# **Report of Geologic Reconnaissance**

**Neuman Parcel Map  
18489 Ramona View Drive  
Ramona, CA 92065  
TPM 20962, ER 05-09-021**

**May 27, 2009**

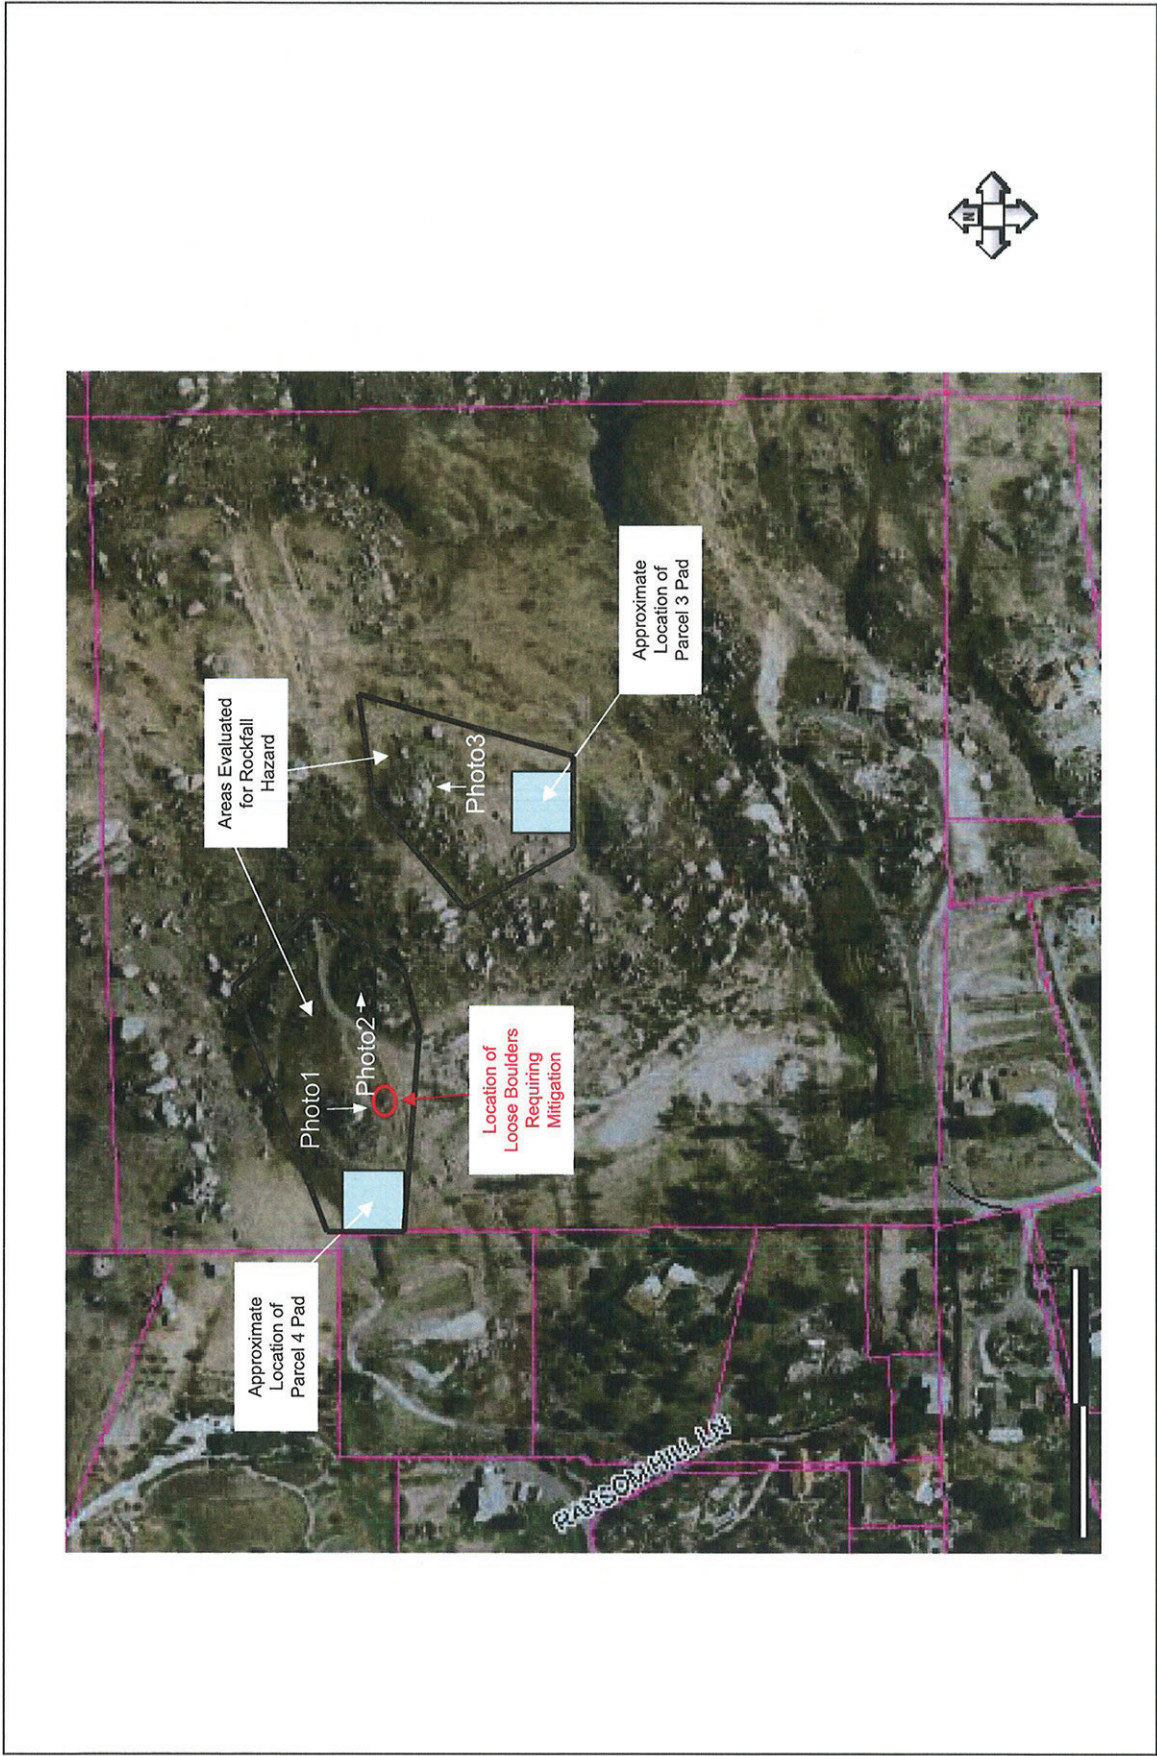
**Figure 4**  
**Rockfall Hazards Identified**  
**TPM 20962 Neuman**

**Parcel 4:** Several boulders were observed in a cluster approximately 125 feet above the proposed building pad on Parcel 4 which could adversely affect the proposed building pad area (Figure 4, Photograph 1). Other boulders/ outcrops observed during our field visit that could potentially affect the proposed building pad on Parcel 4 appeared to be buried to a significant degree and not sitting directly on the ground surface, and/or irregularly shaped with their long axis perpendicular to the slope face.

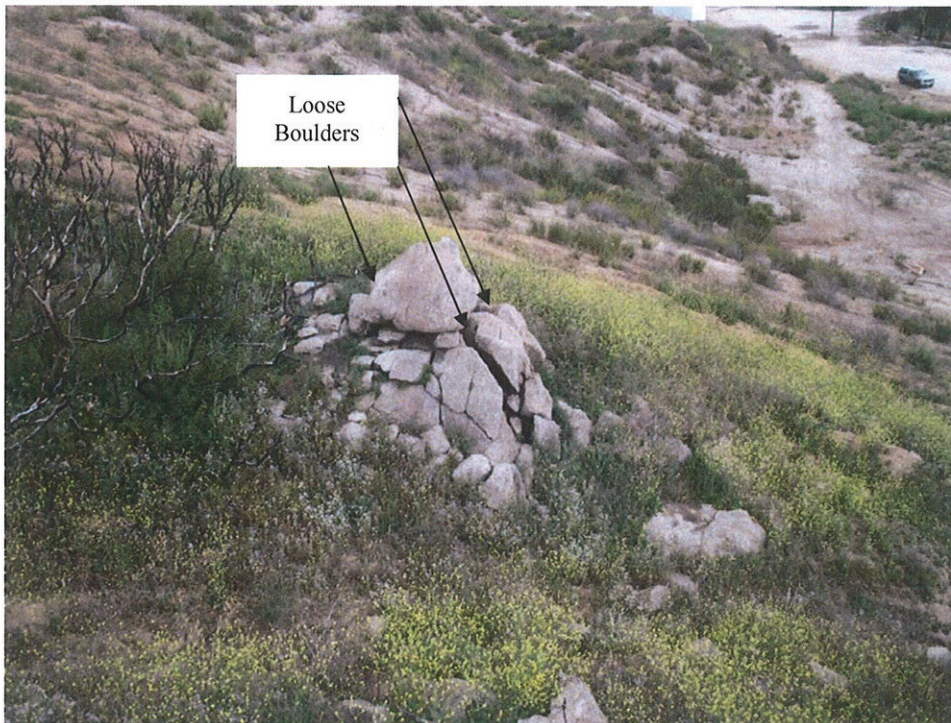
Based on the results of this reconnaissance to evaluate the potential for rockfall, there is one area above the proposed building pad on Parcel 4 which contains loose rocks/boulders which require mitigation. The rocks present on the remainder of the steep slopes observed above proposed building pads on Parcels 3 and 4 do not constitute a substantial hazard. The proposed building pads on Parcels 3 and 4 are safe for human occupancy in their present locations provided the hazardous rocks identified above the proposed building pad on Parcel 4 are addressed as recommended below:

Photograph 1: View to the south of slope above proposed building pad on Parcel 4 with loose boulders shown that require mitigation.

**Intent:** In order to avoid rockfall hazards that threaten the proposed building site, the boulders located in a hazardous position shall be removed.

**Description of requirement:** The boulders identified above the proposed building pad on Parcel 4 in the April 22, 2009 Report of Geologic Reconnaissance prepared by the Department of Planning and Use (DPLU) shall be removed or relocated.

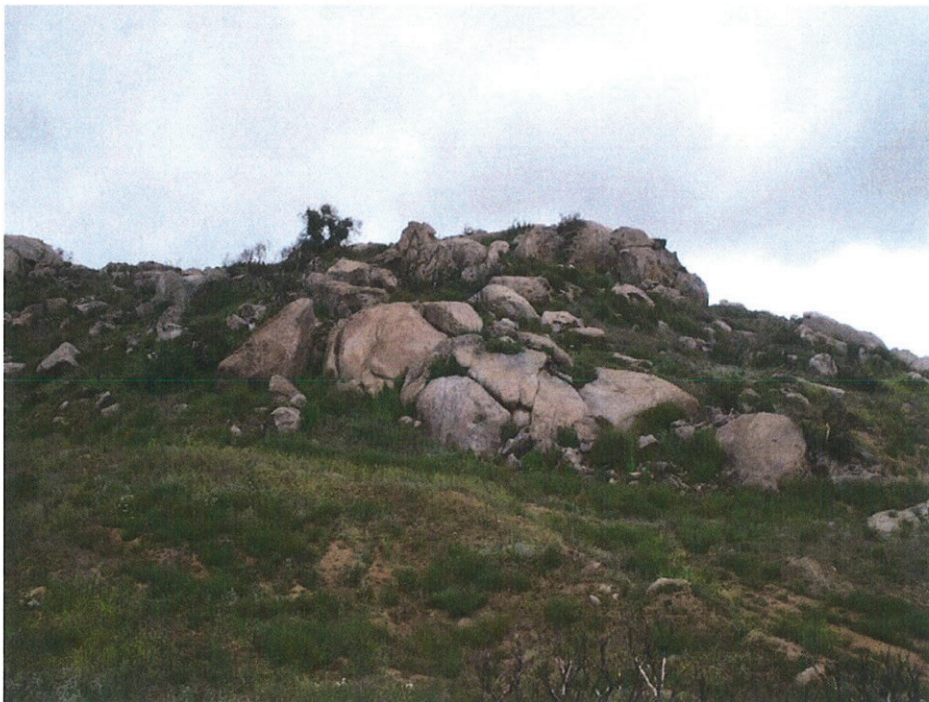
Photograph 2: View to the east of boulders/outcrops above the proposed building pad on Parcel 4.

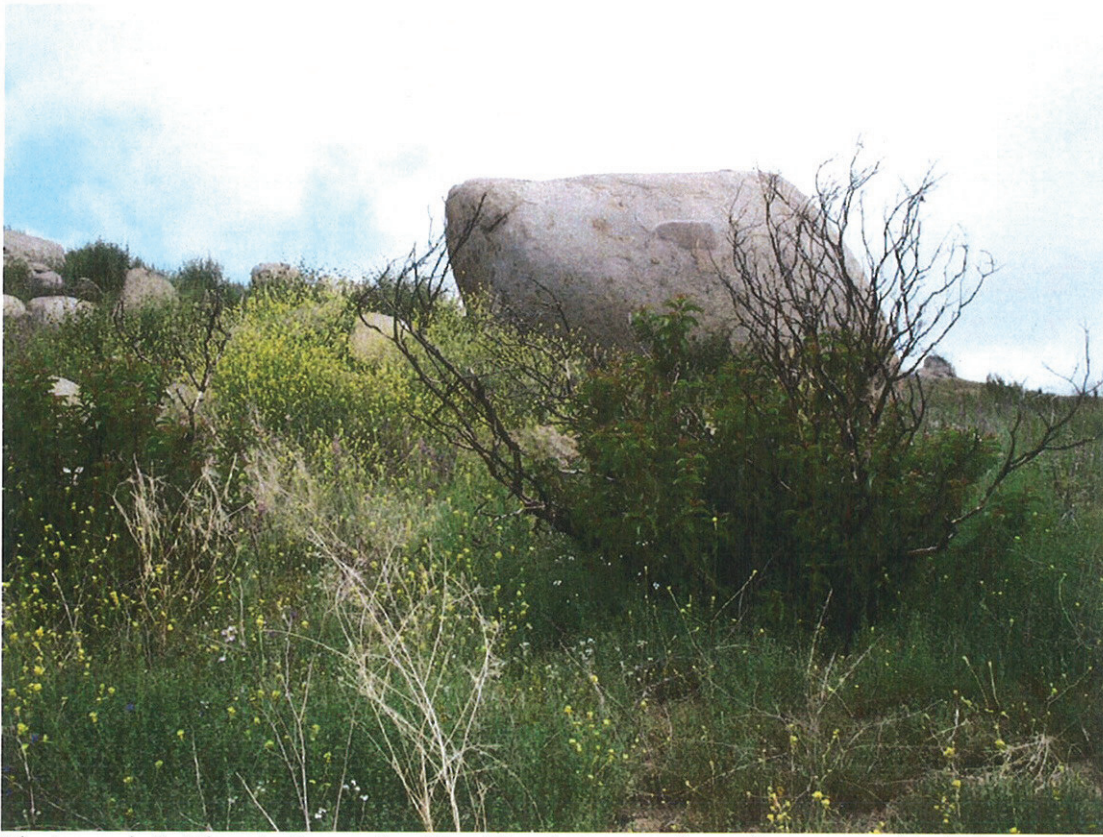
**Parcel 3:** Boulders/ outcrops observed during our field visit (Figure 4) that could potentially affect the proposed building pad on Parcel 3 appeared to be buried to a significant degree and not sitting directly on the ground surface, and/or irregularly shaped with their long axis perpendicular to the slope face. Based on the observed character of the granitic boulders and outcrops, the potential for rockfall to adversely affect the proposed building pad on Parcel 3 is less than significant.

Photograph 3: View to the north of boulders/outcrops above the proposed building pad on Parcel 3.
